An unfinished temple at the Classic Maya centre of Aguateca, Guatemala

Takeshi Inomata,¹ Erick Ponciano,² Oswaldo Chinchilla,³ Otto Román,⁴ Véronique Breuil-Martínez⁵ & Oscar Santos⁶

Keywords: Maya, Aguateca, unfinished temple, construction methods, collapse

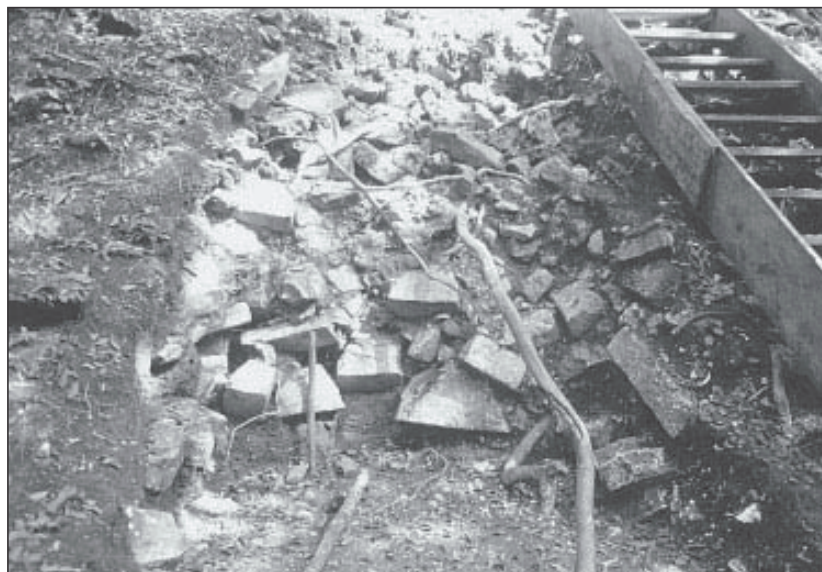
Figure 4 Faced wall during excavation. Note the presence of soil and mortar used in backing masonry as well as collapsed cut stones.

The first and second terraces of the two sides and adjacent parts of the front and rear had been completed (Figures 4 and 5). They were faced with cut stones cemented with mortar, and fragmentary remains of plaster were preserved on the surface of some cut stones. Maya

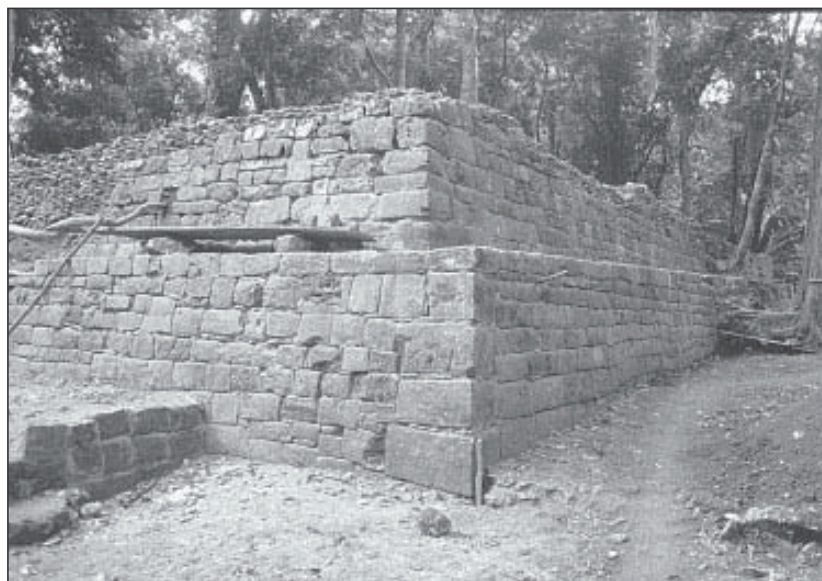
Figure 5 Faced wall after restoration (north-eastern corner of the building). Our restoration only used original stones and no new blocks were added.

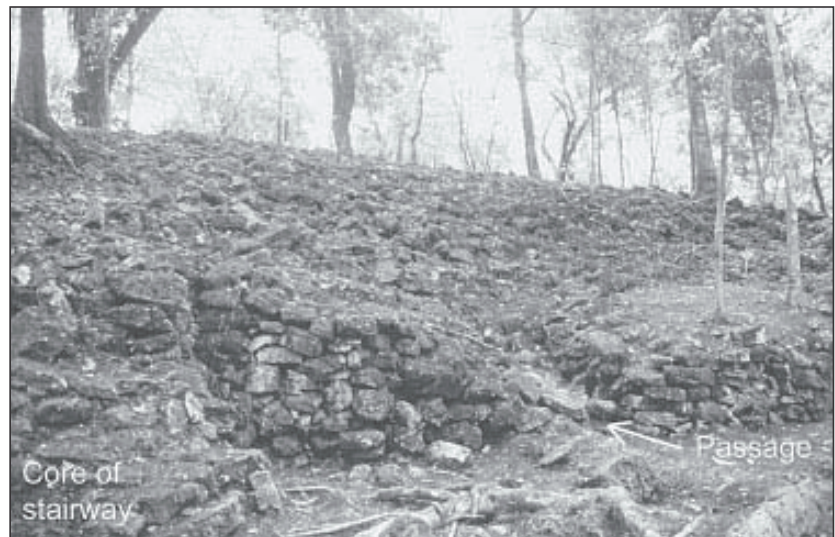
Figure 6 Northern front section of the building before excavation. Note that the stairway core and construction bins stood with little soil. A passage between construction bins is visible.

In the centre of the front section was a stairway. Its steep lower portion was relatively well-preserved, but lacked dressed stones or mortar (Figure 6). This is probably a construction stairway or the core of a stairway, which was meant to be covered by another layer of stairs made of cut stones.

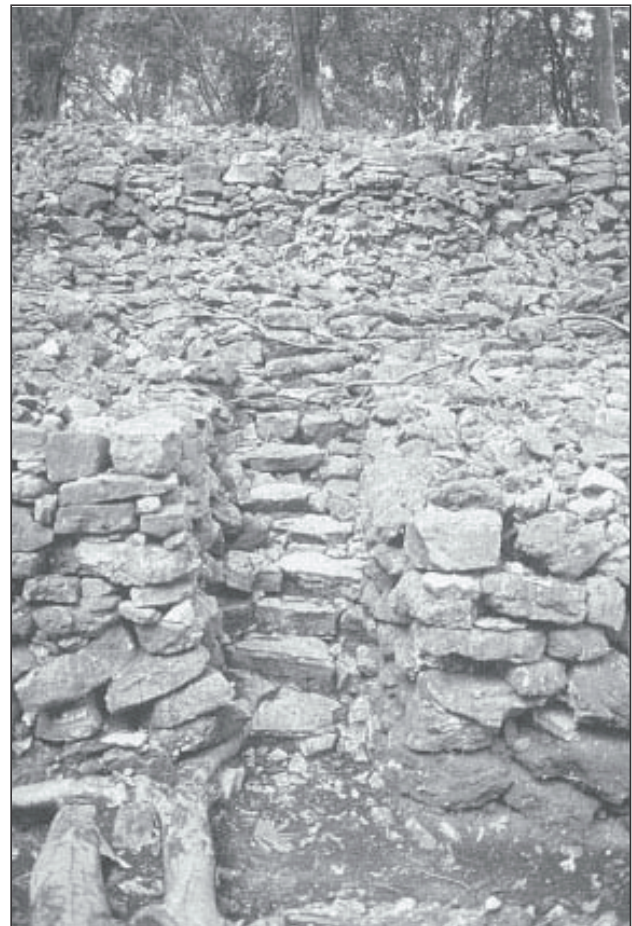
Figure 7 The passage between construction bins after restoration. Note the coarse stairs in the passage (the stairs are not restored).

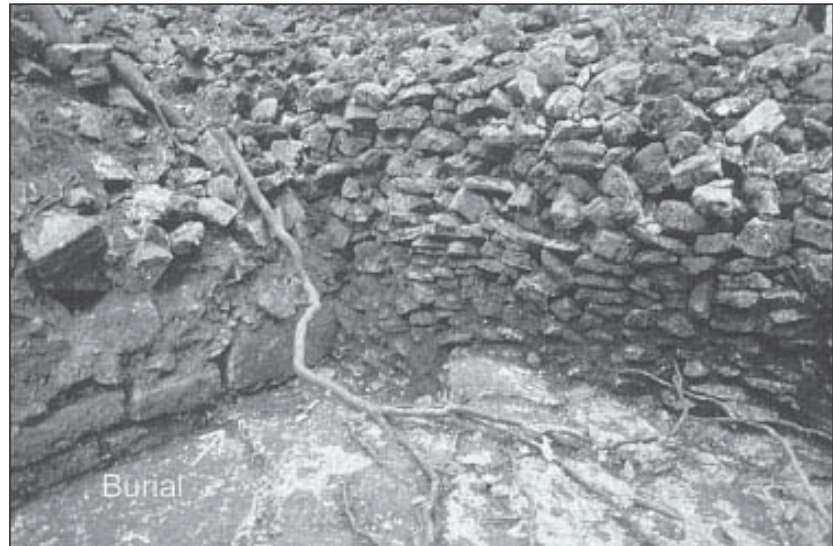
Figure 8 The intersection of the rear wall of the building (left) and the northern edge of the reconstruction ramp (right) after excavation. Note that the retaining wall of the ramp still stands in a near vertical position. Excavators revealed a burial on the solid bedrock.

The large, sloping pile of rough rocks in the rear of Structure L8-8 was most likely a construction ramp, which facilitated access to the centre and top of the building. On the northern edge, its retaining wall still stood nearly in a vertical position. The ramp slightly bent to the south to avoid a nearby residential group. The ramp was probably added after the core of the first terrace was completed. Builders then placed dressed stones over the faces of the northern and southern rear portions of the first and second terraces that were not covered by the ramp. After or during the facing of the first and second terraces, they began to construct the core of the third level on the north and south sides. The cut stones on the faces of the first and second terraces and the cores of the third terrace ended abruptly along the edges of the construction ramp (Figures 8 and 9). The masons

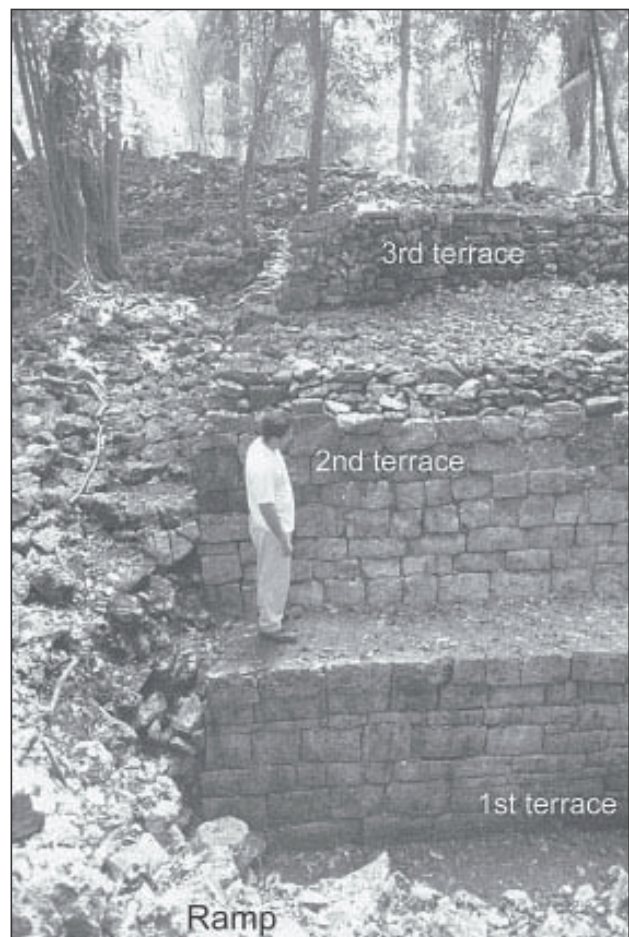
Figure 9 The southern rear section of the building after the added part of the construction ramp was removed. Note that the well-preserved retaining walls of the first and second terraces and the partially restored core of the third terrace end in a straight line along the edge of the ramp.

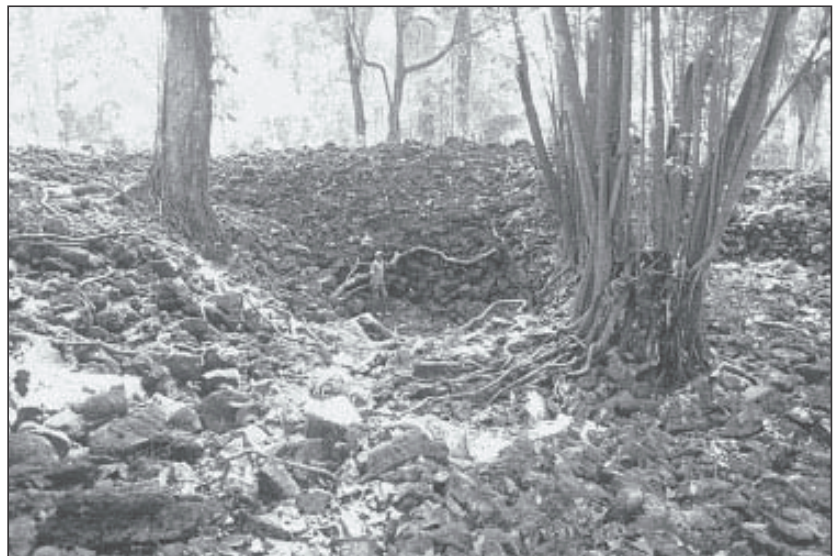
Figure 10 The central depression viewed from the construction ramp. A core retaining wall is visible on the viewer's right of the person.

The central depression of Structure L8-8 was not caused by recent looting. This is implied by an old tree growing inside. Nor is it likely to have resulted from ancient looting, because its size (12 m wide and 3.5 m deep) is substantially larger than other known looting holes in the Maya lowlands (Figure 10). Our excavation of this feature revealed a portion of a dry-stone retaining wall of the building core under collapsed stones. Thus, the depression appears to be part of the original design of the building, possibly for housing a royal tomb. An additional function planned for the construction ramp
